ASPECTS CONCERNING THE PRESERVATION STATE OF VAMA CHURCH IN THE BUCOVINA VILLAGE MUSEUM, SUCEAVA

Loredana Axinte*

Bucovina Museum Complex, 33, Stefan cel Mare Street, 720003 Suceava, Romania

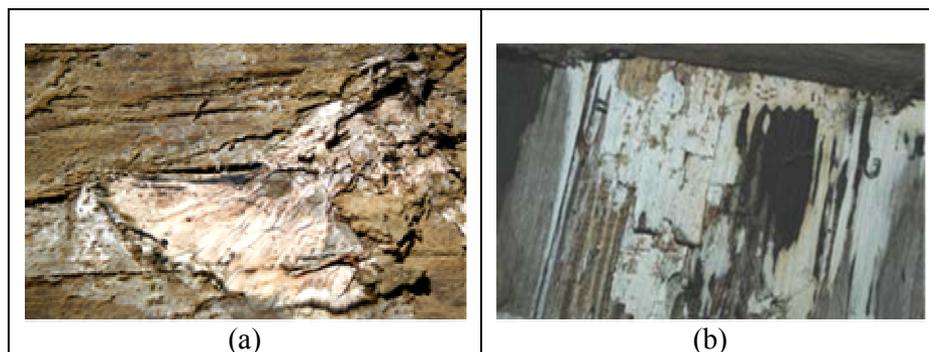
The specialists, who worked of the Vama church in the Bucovina Village Museum in 2005, have been confronted with a very difficult situation, namely the important damage caused by *Serpula lacrymans* (Figure 2a). This fungus attacked some construction elements from the inferior part (the foundation and floor). In this case the specialists resorted to the removal and the burning of the infected elements as well as of those in their vicinity. The other construction elements (old and new wood) were treated by immersion into a watery solution (10 %) of copper sulphate (55%) and potassium bichromate (45%) before the reconstruction. The treatment was repeated by spraying the areas with the same solution in May and September.

The researches which dealt with the study of the macrofungi on the structure wood of the Vama Church, took place from November 2006 to June 2007. During this period there have been encountered five species belonging to the *Basidiomycota* subkingdom (Table 1) [4].

Figure 2. Macrofungi found on the wood structure structure of the Vama Church: (a) *Serpula lacrymans*, (b) *Hypodontia breviseta*.

During the period in which researches were conducted there haven't been signs of a possible come-back of the fungus *Serpula lacrymans*, joyful fact which brings about the conclusion that the anti-fungal treatment has been efficient.

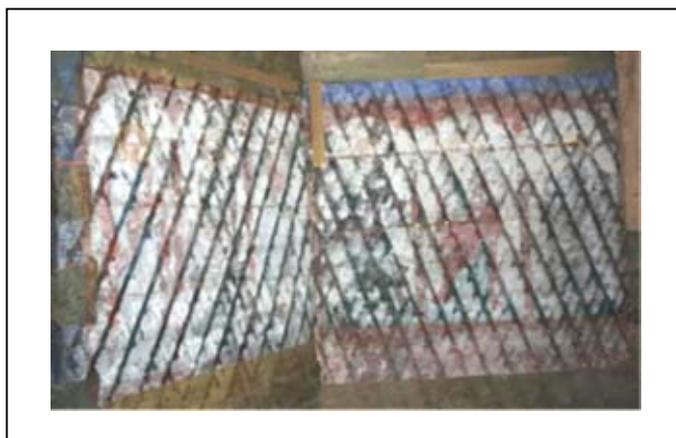
On the vaults of the altar and nave one may still notice painted areas which represent the starry sky while on the walls of the altar's apse there are four fragments which represent saints standing up (Figure 3). The painting is accomplished in the distemper – tempera technique, a faulty execution achieved

The mural painting is in an advanced state of damage caused by the author's technique, the combined action of many degradation factors: physical, chemical, biological as well as by the interferences and changes undergone in time by the monument [5].

The painting is on an irregular, very thin and fragile layer of preparation and colour which is also deficient in binder (isinglass dissoluble in water), fact brought about by the permeations caused by the rain. The curved ribs found at the joint of the boards which make up the arches have been repainted using a consistent layer of ordinary, common dye.

Figure 3. Mural painting on the walls of the altar's apse.

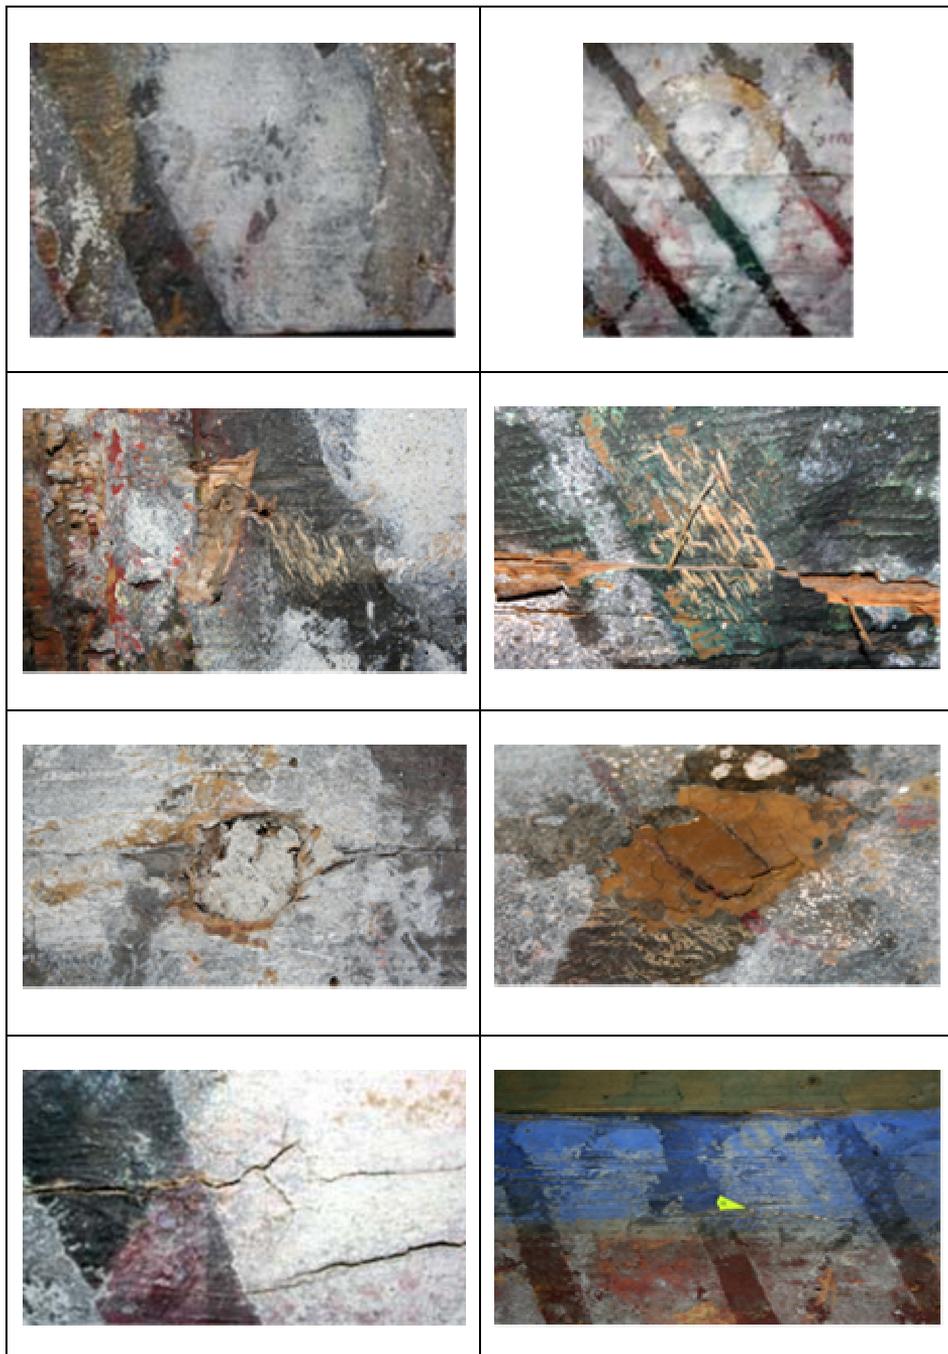
After the plaster and the laths have been removed the painting showed different types of damage as a consequence of the traumas caused by an aggregate of agents (physical, chemical, biological, human, etc.): detachment of the pictorial coat, gaps, fissures, brought about by the diminishing of the binder's concentration, chromatic changes of some pigments (blue, green), adherent and non-adherent deposits (dust, smoke, plaster, wooden chips), holes and other damages engendered by nails and other metallic elements (Figure 4).

Figure 4. various types of damages found on the mural painting of the altar's apse: adherent and non-adherent deposits - dust, smoke, plaster, wooden chips, gaps, ulterior inadequate quits, exfoliations, chromatic changes.

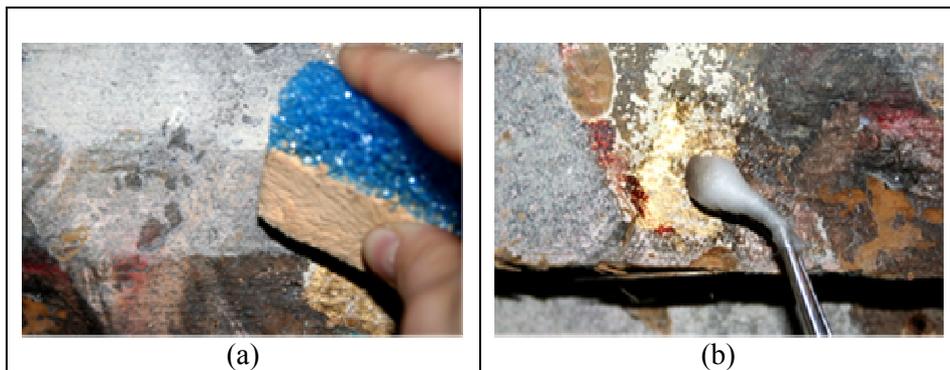
Figure 5. (a) Dry clean tests, (b) wet clean tests.

The researches as well as the specific documentation have been conducted for painting restoration purposes. We mention that the cleaning tests have given us the hope that the most part of the painting found under the layer of plaster has a chance to be retrieved (Figures 5 and 6).

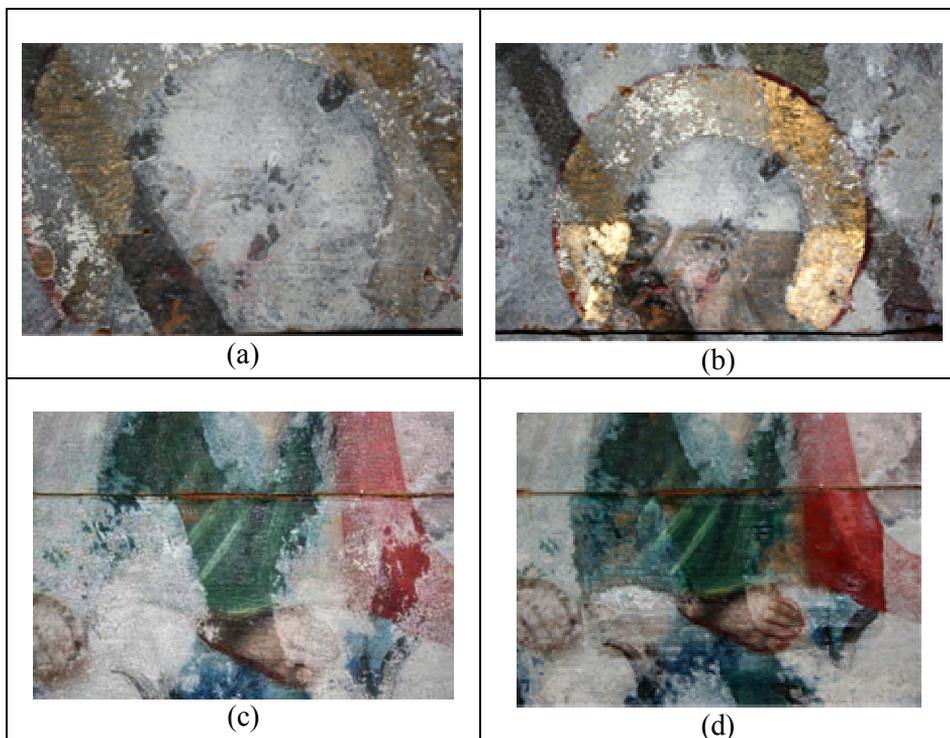
Figure 6. Detail of mural painting: (a, c) before being cleaned; (b, d) after being cleaned.
