# NON DESTRUCTIVE EVALUATION OF LANTERN TOWER CHURCH OF DRAGOMIRNA

Ileana Kisilewicz\*

## Abstract

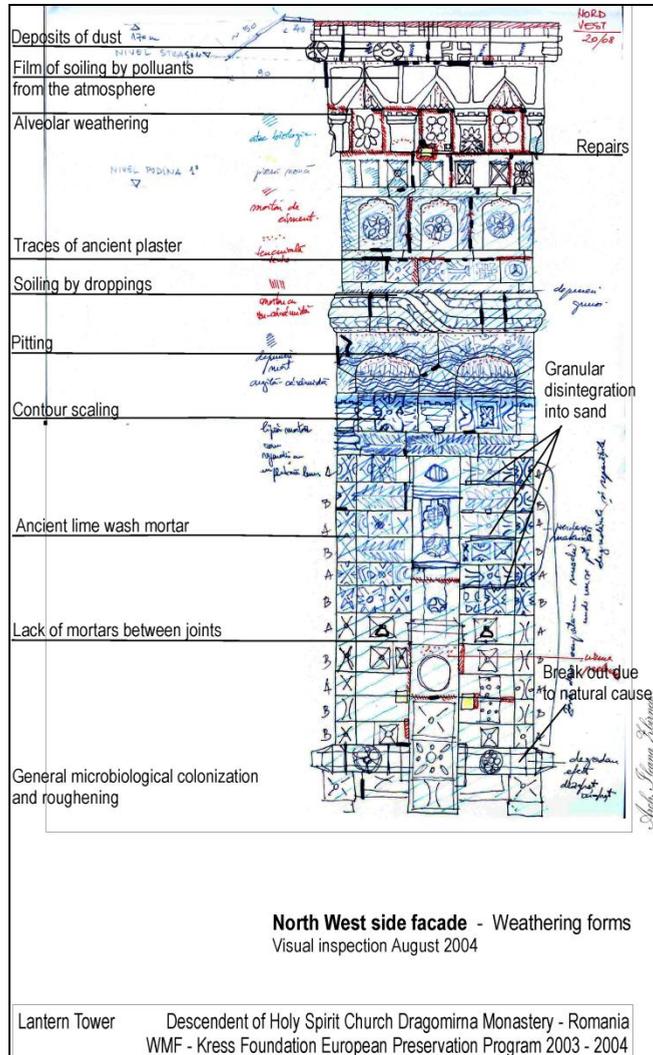
Figure 1. Scheme of pathology on N-W side of lantern tower.

Evaluation revealed the largest pathology occurred on W, N-W and N sides of lantern tower then it decreased slightly towards S side. As the mineralogical report demonstrated that the N-W dominant wind direction and

the absence of direct sun light plus the high humidity plus the low temperatures influenced the increase decay of stone surfaces of these sides.

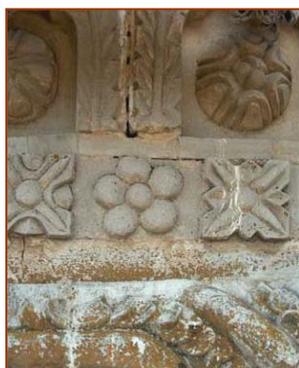
**Figure 2.** Soiling by droppings from birds and biological colonization.

stonework around the tower. They were visible especially in lower parts of spin cord motif. The upper parts of lantern tower sides were often less affected by the growth of biomats properly (Figures 2 and 3).

For the conservation of the original surface it seemed, not only for esthetical reasons, useful to remove the biological layer (biomats). In order to minimize the re-growth of microorganisms, especially lichens, it was proposed

to treat, after a mechanical brushing the stone surface, with an H<sub>2</sub>O<sub>2</sub> solution, which should oxidize the remaining organic matter. Thus, the 'disinfected' stone surface could slow down the growth of microorganisms and could diminish the problem for at least 20 years. Otherwise an acceleration of biological colonization and an increase of deterioration of the limestone surface should be feared.

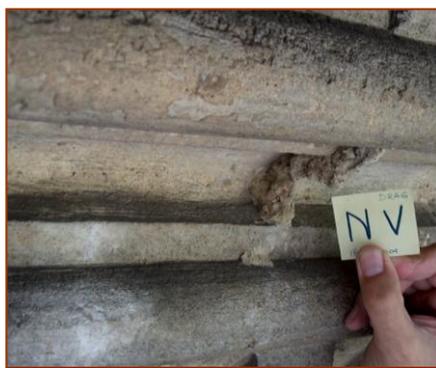
**Figure 3.** Deposits of dust – mud and vegetal material and film of soiling.

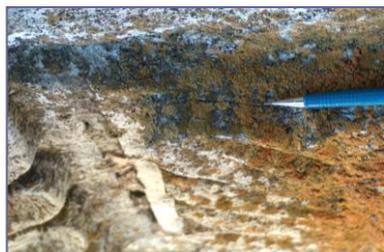
**Figure 4.** Detachment on contour scaling and deposits of biological colonization
