**NON-DESTRUCTIVE TESTING FOR THE
ASSESSMENT OF STONE DECAY IN RELIGIOUS
HERITAGE
CHURCHES OF SAN ROQUE (SEVILLE) AND
NUESTRA SEÑORA DE LA ANTIGUA
(TORREALHAQUIME, CADIZ)**

Rosario Villegas Sanchez* and Fátima Arroyo Torralvo

*University of Sevilla, School of Engineering, Camino de los Descubrimientos, E-41092 Sevilla,
Spain*

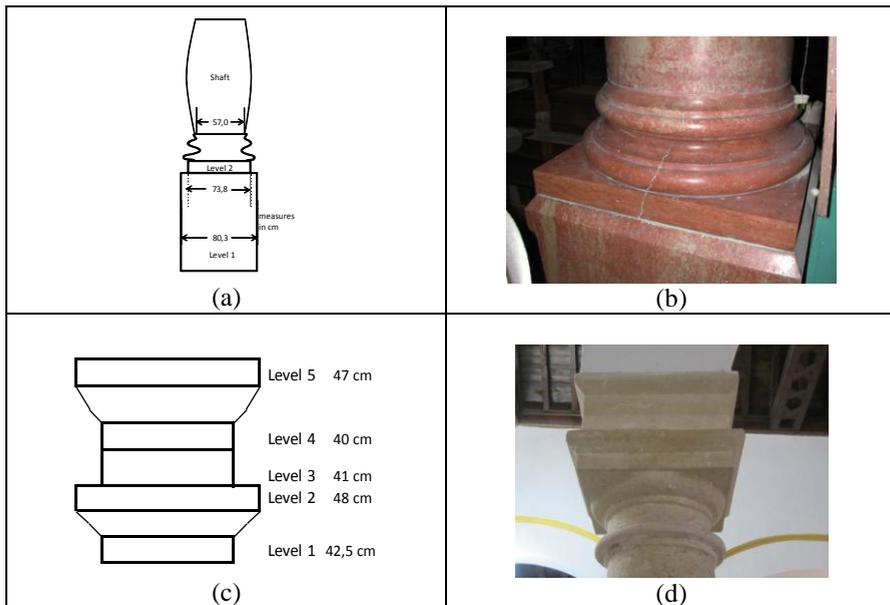
San Roque has six columns made of a red micritic brechoide limestone, with the configuration shown in Figure 2a. The problems are located on the bases and on the lower part of the shaft on column 1 (Figure 2b). Measurements on the two square pieces that formed the base, on both directions and on three points of each face were carried out. When irregular values of propagation time were obtained, we took measurements each 10 cm all along the face.

Figure 2. (a) Schematic representation of the columns of San Roque with (b) a detail of the base of column n° 1; (c) the schematic representation of the capitals of Torre Alhaquime church with the average measures for the four capitals, and (d) a detail of the capital 2.

Torre Alhaquime has four columns made of a calcarenitic stone, as well as the capitals, where the cracks appear. The configuration of the capitals is represented on Figure 2c-d, each part being made of a separate stone block. We made measurements at five levels on each capital, on three points of each face and on both directions.

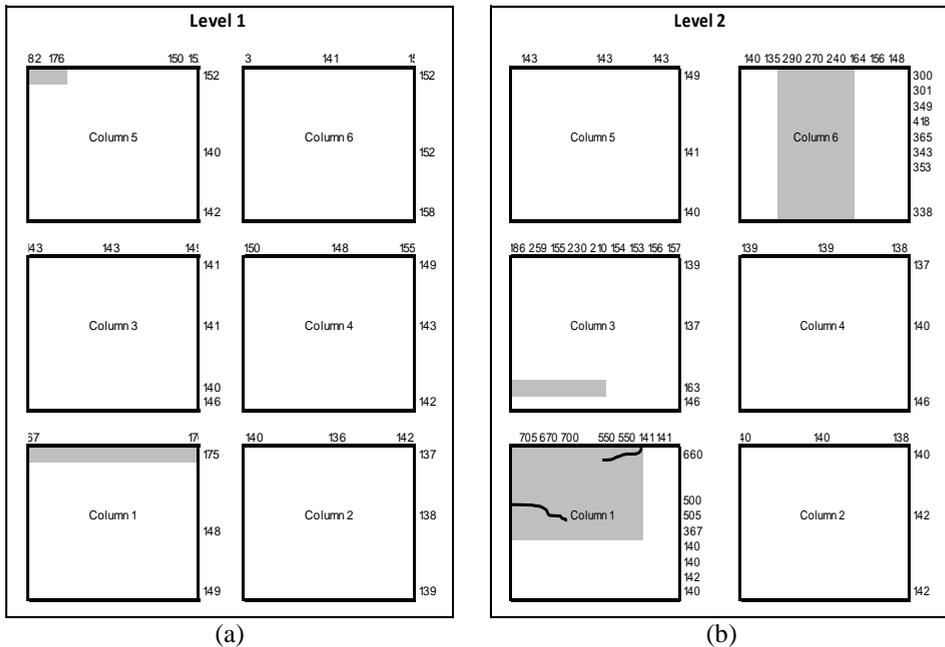
The average velocity obtained on the six columns ranges between 5200-5300 m/s, showing the high compactness of the stone.

On Figures 3 and 4 are presented the results of transmission times on both levels of the bases. The normal values, 150 μ s on level 1 and 140 μ s on level 2, correspond to the average velocity of ca 5250 m/s. When high values are obtained, zones with deterioration, marked on grey, can be defined. This deterioration does not consist on decohesion or loss of compacity, and it is only evident on column 1, which presents two fissures on level 2 (Figure 2b). On the other columns, the defects probably are internal and only detectable by this technique.

Figure 3. Transmission time (μ s) on San Roque columns at: (a) level 1 and (b) level 2.

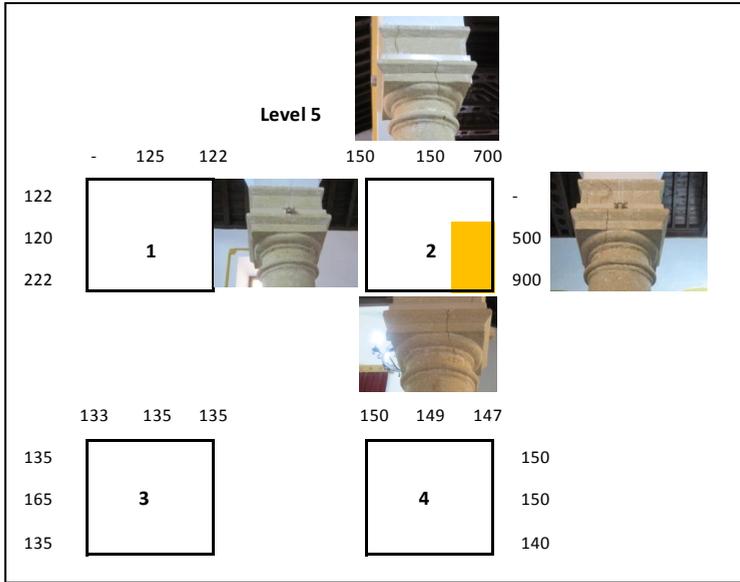
Figure 4. Transmission time (μ s) on Torre Alhaquime capitals at: (a) level 5 and (b) level 3.

As an example, on Figure 4a are shown the results of level 5 with the pictures of column 2. It is clearly seen that the cracks cause a high time of ultrasonic transmission; the same situation occurs in the lower levels of this column (Figure 4b for level 3).

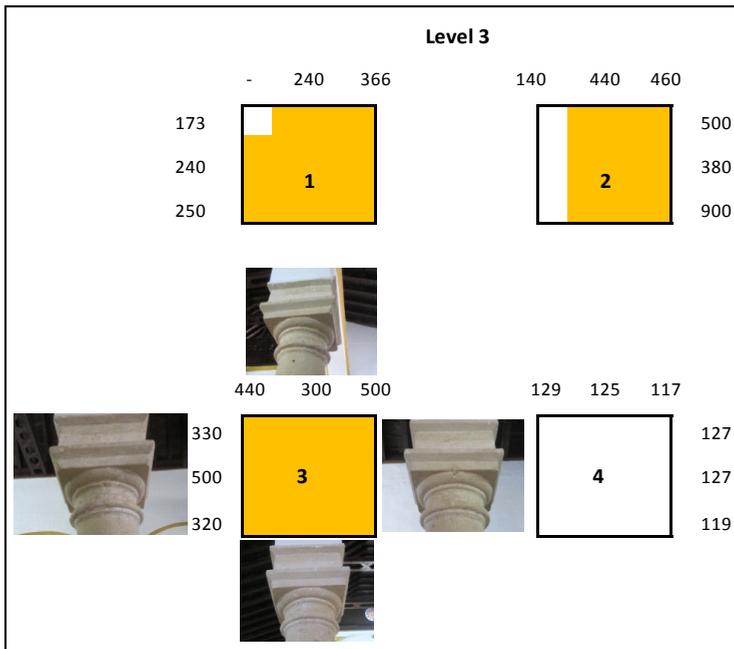
(b)

Column 4 has a similar situation with the column number 2, while 1 and 3 did not show macroscopic external deterioration. In spite of this, the values of transmission time on columns 1 and 3 for level 3 are very high on every measure points, which could be related to an internal failure (Figure 4b).

On both churches under study, with the use of this technique it has been possible to detect the existence of non visible defects on the stone elements that form part of the columns that have to be investigated more extensively in order to secure the building.
