# ANALYSIS, DIAGNOSIS, CONSOLIDATION AND WATER REPELLENT TREATMENT OF THE BURGOS CATHEDRAL STONE

María Dolores Robador<sup>1</sup> and Jose Luis Pérez-Rodríguez<sup>2,\*</sup>

## Abstract

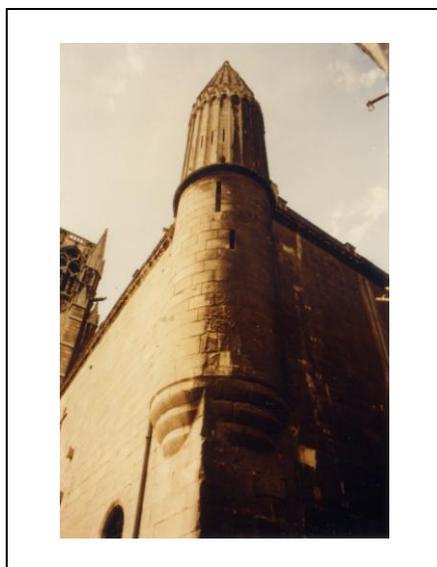
The cartography was carried out by visual observation. White zone or washed stone: the forms of alteration that dominate this area are discoloration of the stone due to washing without an observed loss of thickness. The development of these alteration forms depends on the situation and orientation of the stone (reliefs, faces runoff, etc.). Most stones retain their consistency, and the alteration degree can be considered low. However, a few zones do appear to have notable mass loss, especially under reliefs and sculptures. Grey areas or dry deposits: these zones can be found in the areas of the building protected from rain and runoff. The surface of the stone is subjected to continuous deposition from the environment. The stone is not altered because the surface deposits do not react chemically with the surface of the stone. Black areas of wet deposits: these areas appear in protected zones that are next to rain areas. These zones are characterised by constant humidity. Exogenous deposits are retained in these areas because of their reaction with the stone. These areas exhibited notable alterations, mainly crusts that evolved and gave rise to desegregations associated with efflorescence. The zones most favourable to these processes are the interiors of the cornice and outgoing. Green-yellow zones: these zones appear in areas of the building exposed to rain and heat. Plants, lichens and algae have developed there. Figure 2 shows a photo carried out before the façade restoration. It is shown clearly the orientation effect on the alteration. The south-west façade show white colour due to erosion of rain water and environmental contamination that produce the alteration of this façade zone. On the other hand the south west façade show a black superficial crust. In this zone of the building appear absorption water by capillarity and do not receives sunlight directly. In addition receive environmental contamination due to cars traffic.

**Figure 2.** White and black alteration.
