TECHNICAL RESCUE WORKS ON THE CONSTRUCTION OF THE SAINT ANNE'S CHURCH IN WARSAW AS AN OPPORTUNITY TO STUDY THE TECHNIQUE, TECHNOLOGY AND ICONOGRAPHY OF THE XVIII CENTURY MURAL PAINTINGS

Katarzyna Górecka*

Abstract

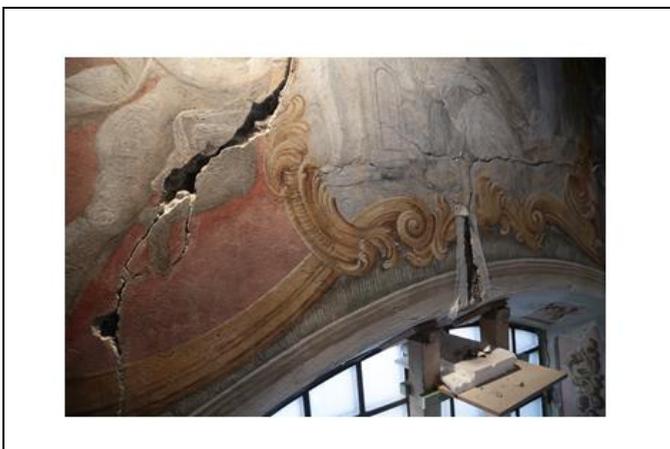
Figure 3. Cracking of the wall structure and plaster layers.

In the years 2010-2013 some brick elements got loose in the widow lintels and dangerous delamination of the plaster on the north wall was observed (Figure 3). A serious structural rupture of the wall ran along the north facade (in the last span). In the upper part of the wall appeared a structural dissection of the brick wall above the window in the second storey (Figure 4). The rupture was more than 1 cm wide and reached approximately 45cm into the wall, the loose wall moved forward and downward. Repeatedly fixed stucco elements and cornices broke again.

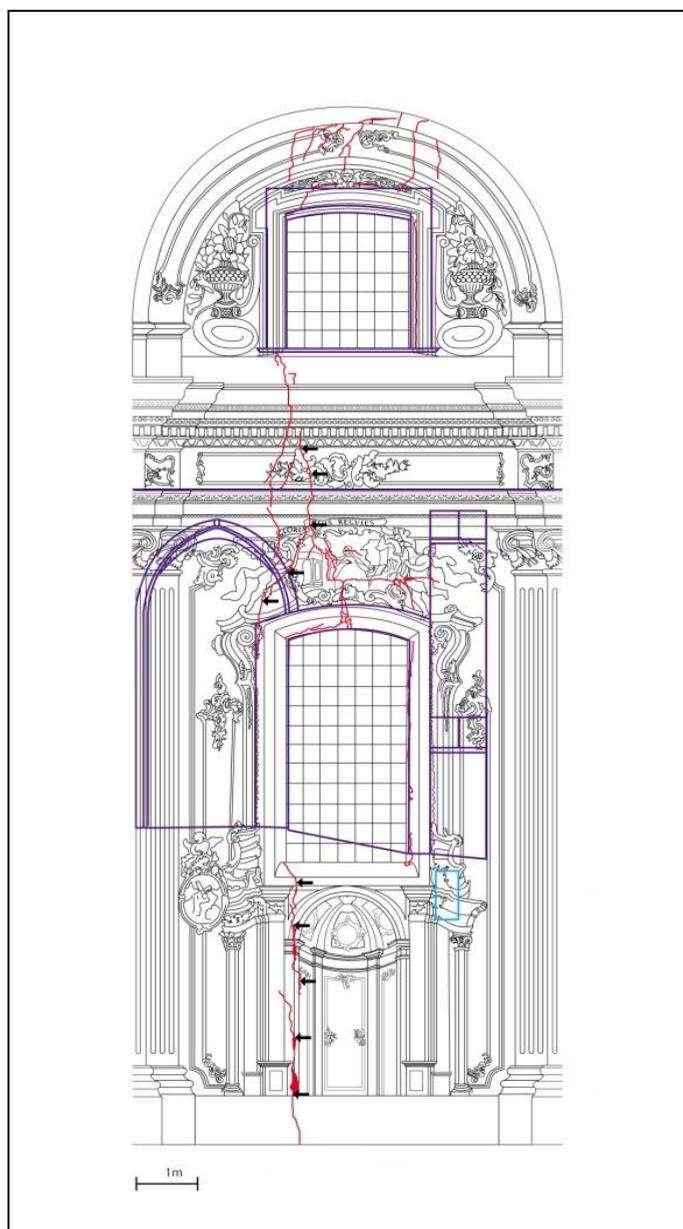
Figure 4. Cracking of the north wall, drawing by B. Rabiej.

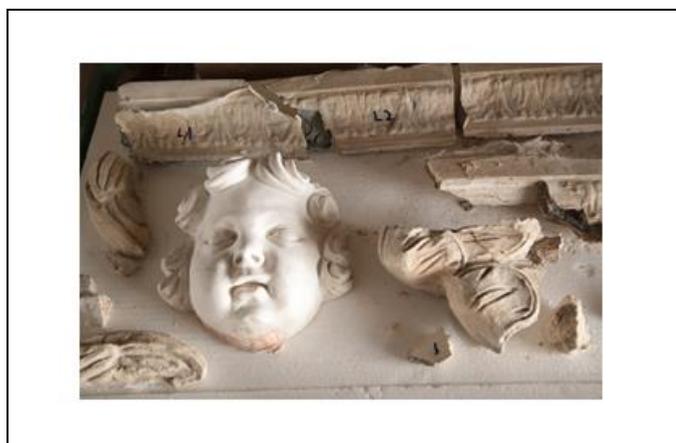
Figure 7. Removed stucco elements.

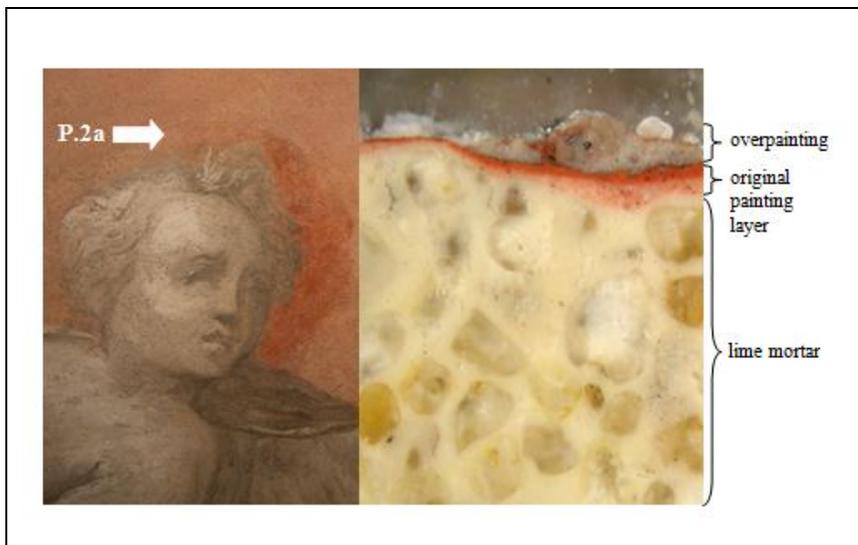
Figure 9. Original red painting layer was covered by overpainting.

The mural paintings by Valenty Żebrowski date from 1750 to 1764. They were carried out in secco technique on the lime mortar with coarse quartz filler. The artist's palette consists of the following pigments: ochre, red iron oxide (Figure 9), smalt, white limestone, black wood and green earth [E. Jeżewska, *Chemical analysis of the samples taken from the northern wall of the St. Anne's church in Warsaw, XVIIIth century paintings by Valenty Żebrowski*, (manuscript), Warsaw, 2013, 4-19]. This is the third in order of the painted decorations of the church interior. Under the XVIIIth century plaster some relics of the earlier polychromes were discovered.

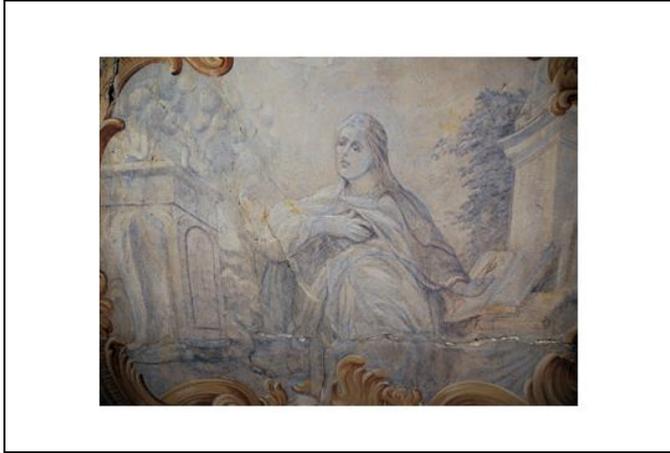
In the UV light some unknown elements of the composition became visible: a broken column, books and volutes surrounding the cartouche (Figures 10 and 11). The scene is crowned with a Latin sentence, written on the band above: 'GLORIA EIUS REQUIESCET'. This quotation from the Book of the Wisdom of Sirach (Sir. 14.27) in translation reads: 'WILL BE REST IN HIS GLORY'.

Figure 10. Central part of the painted cartouche, state before conservation.

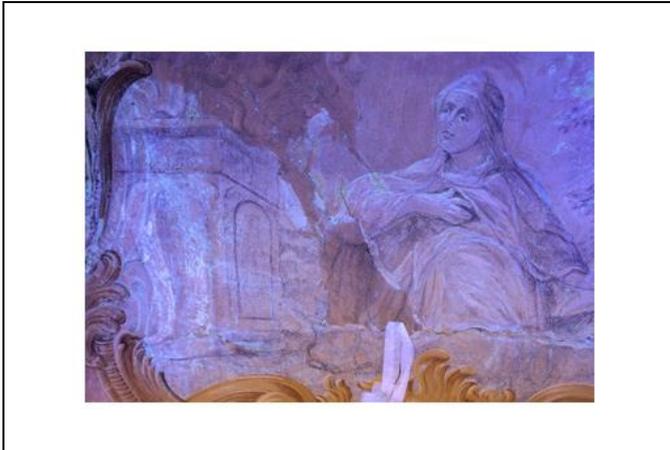
Figure 11. UV light investigation.

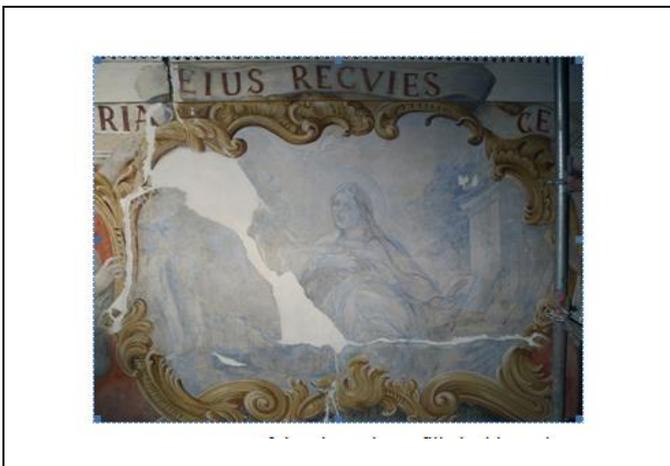
Figure 12. Loses of the plaster layer filled with putties.

A special wisdom of the woman was suggested by accompanying attributes: books and scrolls of the scripture. This interpretation fits the iconographic program of the entire interior painting, where the heroes from the Old Testament are presented in the cartouches. During the restoration work old reconstructions and retouching were removed, missing parts were reconstructed (Figures 12 and 13). The scene regained its true message and original artistic expression [4].

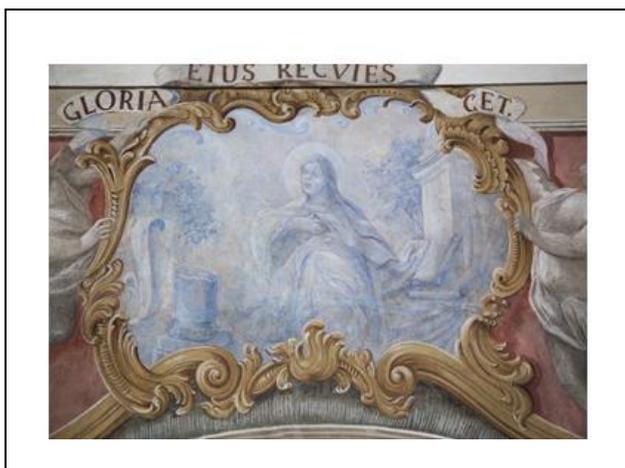
Figure 13. Painted cartouche, state after conservation.
