RESEARCH ON THE MURAL PAINTINGS FROM THE CHURCH SAINTS ARCHANGELS, FROM THE VILLAGE OF AȘCHILEU MIC, COUNTY OF CLUJ

One of the oldest wooden churches from the county of Cluj, is situated in the village of Așchileu Mic. The church, which is a historical monument, was constructed sometimes between 1762 and 1767, and was dedicated to the Holy Archangels Gabriel and Michael. At the very beginning of the 19th century, the church was decorated with mural paintings. This paper presents not only the iconographical and architectural features of the monument, but also the research and the experiment results obtained by applying FTIR method on some samples of mural painting. These analyses were meant to certify the origin of the materials used in the primer and colour layers of the painting inside this very old wooden church.

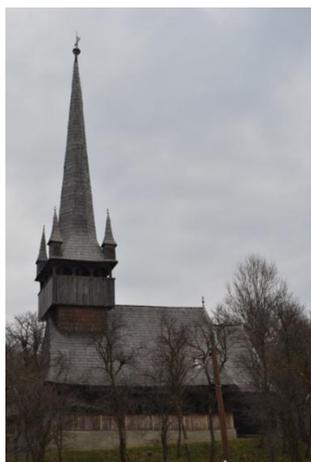
Figure 1. The wooden church from Așchileu.

Due not only to its age and architecture, but also to the icons and mural paintings that it shelters, the timber church from Așchileu is a historical monument that has been included on the National Cultural Heritage list (Figure 1).

shaped church, measuring 13.5 meters long and 7 meters high. On top of the narthex rises a 20 meters high belfry guarded by 4 small towers. The church is surrounded on the western, northern and southern sides by a porch, while a beautiful roof covers the stairs.

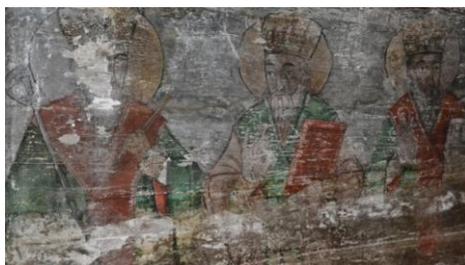
Figure 2. Holy Hierarchs, sanctuary.

In the lower register of the Sanctuary, next to the prothesis, one can see the Descent of Christ from the Cross, while on the rest of the register Holy Fathers and Hierarchs are painted (Figure 2).

For the present analysis many samples were taken from different damaged areas of the mural painting, samples that should provide us the information on the pigments used and the binder (Figures 2, 3, 5). The samples were analysed through FTIR spectroscopy and spectroscopy of atomic absorption.

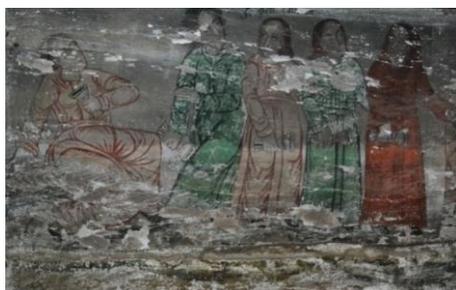
Figure 3. The mad virgins, narthex.

On the southern wall of the narthex, as well as on one side of the western wall, the myrrh-bearing women are painted as they are encountered by the angel sitting on the overturned stone and telling them that Christ has risen. In the remaining space, to the frame of the door, the Holy Emperors Constantine and Helen are represented, while the scene of Abraham's sacrifice is painted above the entrance. In the northern part of the western wall lies the scene of the five mad virgins (Figure 3), which continues on the northern wall of the narthex with the representation of the five wise virgins.

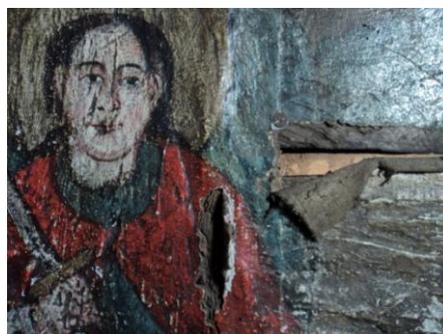
Figure 4. Saint Archangel Michael, nave, eastern wall.

As I have already mentioned, strips of cloths were glued over the places where the ledgers were joined together (Figure 4). Few of them have been preserved in a good state of conservation, most of them being seriously damaged. Some pieces of cloth are detached from the wood, because of the loss of the binder's quality due to aging and exposure to microclimate factors, while others are completely missing. These cloths detached from the support, some of which are kept in their places only by nails, need fast fixing intervention, because there is a risk of losing the existing painting coat.

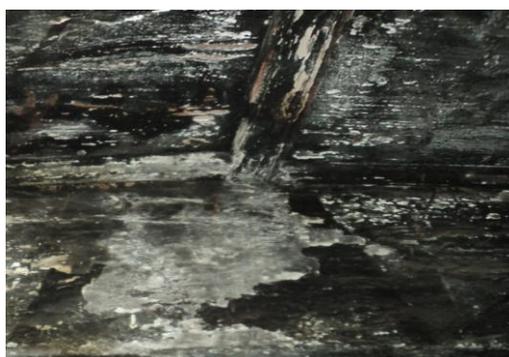
Figure 5. Sanctuary, ceiling.

Up on the semicircular vault of the sanctuary is not painted the Mother of God with the Child, as expected, but the All Seeing Eye of the Lord, a western type representation. Six medallions with the prophets Jonah, Jeremiah, Isaiah, Ezekiel, Zechariah and Daniel may be seen on each side. On the northern part of the vault the scenes of The Raising of Lazarus and the Entry into Jerusalem are painted, while on the southern part lie The Presentation at the Temple and another small unidentified scene.

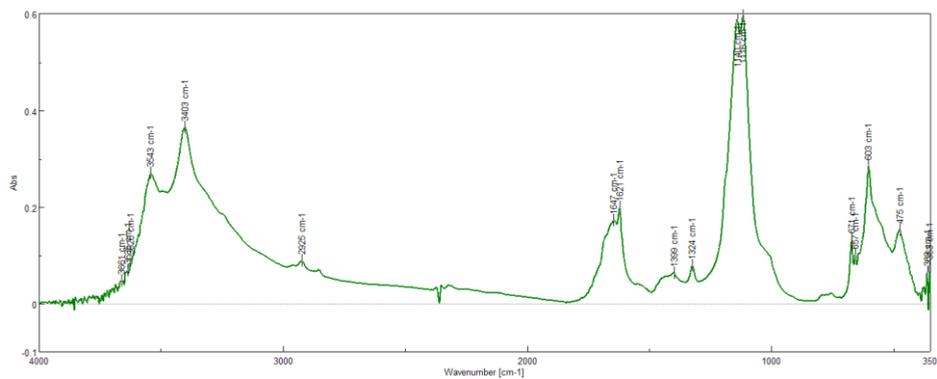
Figure 6. The FTIR spectre of the red colour sample.

- The painting binder used is milk casein (the specific bands 1660-1600, 1565-1500, 1480-1300, 666 cm^{-1});
- The red used is, as was assumed, iron oxide (Figure 6, the specific bands 680-450 cm^{-1});
- The brown used is also iron oxide, used in mixture with carbon black (Figure 7);
- The green used is malachite (Figure 8, the specific bands 3700-3100, 1530-1350, 1100-1000, 900-650 cm^{-1});
- The white used is calcium sulphate (Figure 9, the specific bands 3700-3200, 1140-1080, 671, 602 cm^{-1});
- The yellow used is iron ochre (Figure 10, specific bands 3550-3450, 1600-1500, 1100-1000, 600-500 cm^{-1})

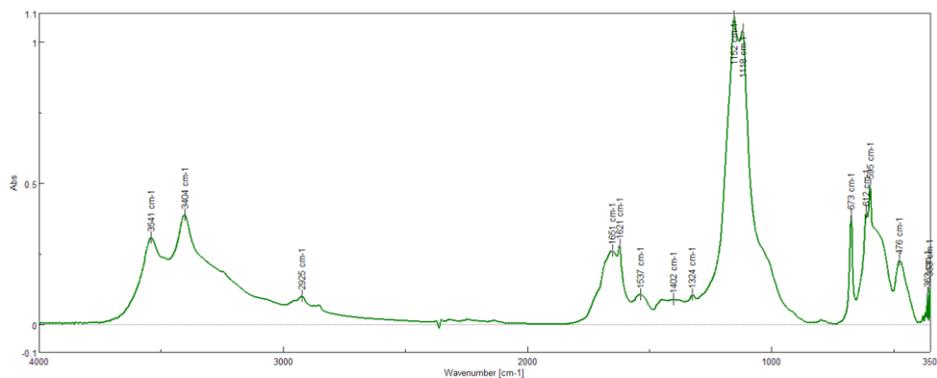
Figure 7. The FTIR spectre of the brown colour sample.

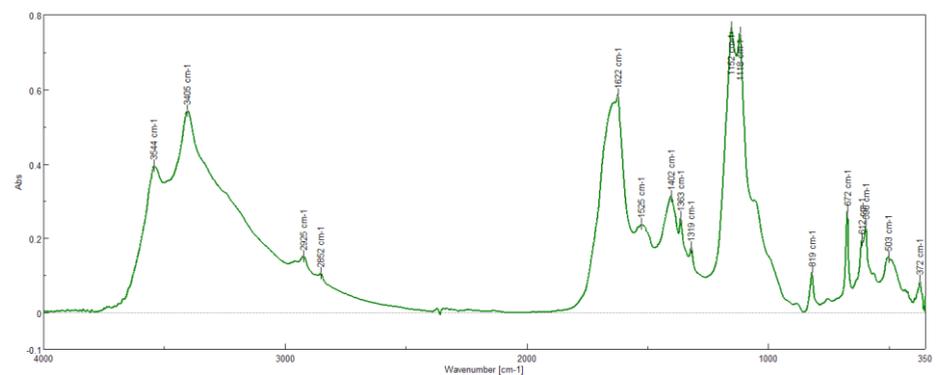
Figure 8. The FTIR spectre of the green colour sample.

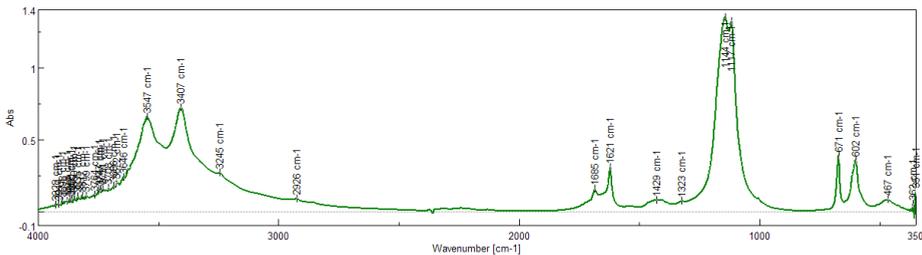
Figure 9. The FTIR spectre of the white colour sample.

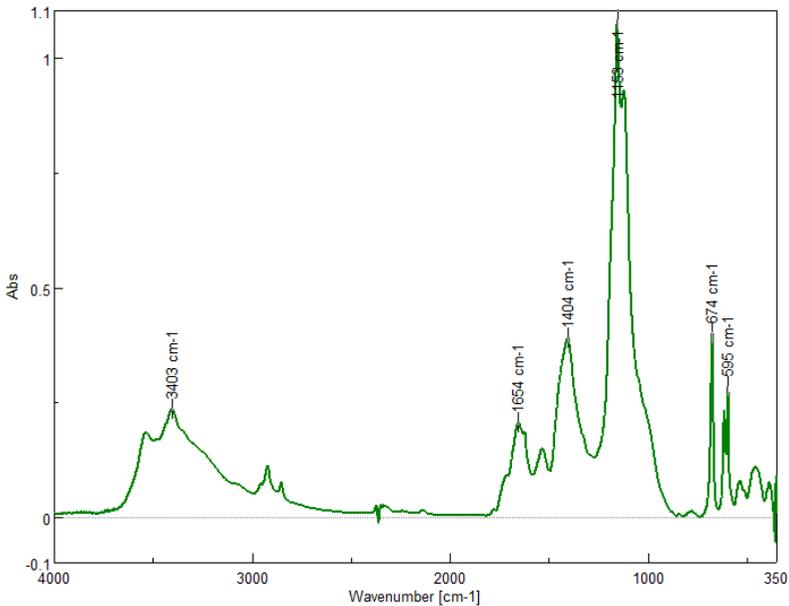
Figure 10. The FTIR spectre of the yellow colour sample.
