# THE MURALS OF THE OLD CHURCH IN MOSTER A TYPICAL NORWEGIAN POST-REFORMATION WALL DECORATION?

Elisabeth Andersen\* and Susanne Kaun

*Norwegian Institute for Cultural Heritage Research, Storgata 2, 0155 Oslo, Norway*

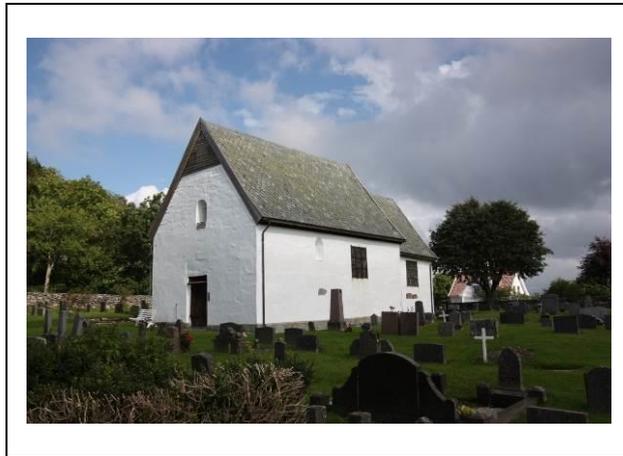
**Figure 1.** Moster Old church viewed from the south-west. It is a typical Norwegian building in Romanesque style with a rectangular nave and a small chancel with saddle roof.

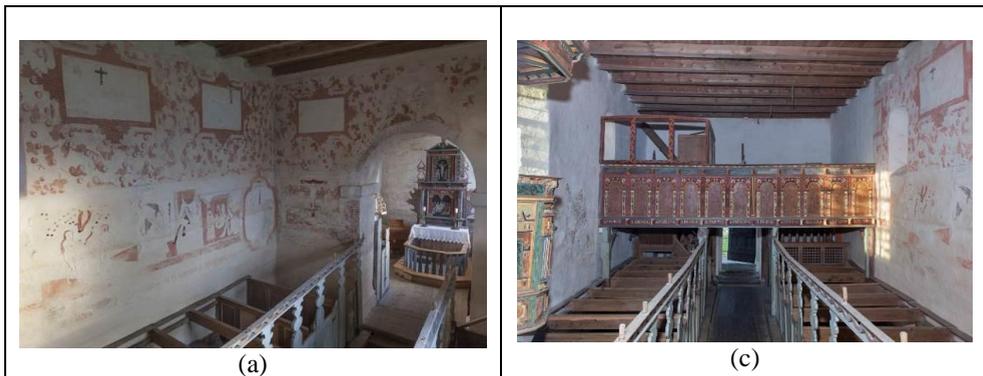
**Figure 2.** Moster Old church: (a) the northern and eastern walls in the nave, (b) the west nave with the western gallery. Photo: B. Lindstad, 2013.

In the 17<sup>th</sup> century, the church interior underwent major changes. The interior is characterized by richly decorated and well-preserved Lutheran assets: the pulpit, the western gallery, the benches, the altarpiece and the murals can all be dated back to the 17<sup>th</sup> century (Figure 2). But the most striking impression on entering the church today is given by the paintings that entirely cover the walls in the nave and chancel.

The murals are divided into two horizontal parts (Figure 2a). The upper part of the wall in the nave is decorated with foliage and fruit ornamentations and painted frames, originally containing inscriptions now lost. The lower part

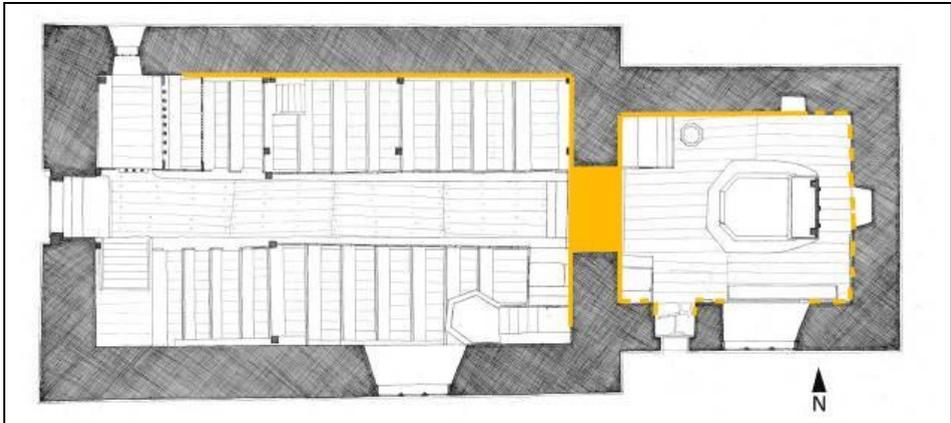
**Figure 3.** Ground plan of Moster Old church. The yellow marks show the location of the post-Reformation murals. Plan: Johan Lindström, 1926.

The remaining post-Reformation murals in Moster cover the northern and eastern wall in the nave, and the northern, western and parts of the southern and

eastern wall in the chancel (Figure 3). Traces of painted decor can also be found on other walls, suggesting that the entire interior may have been decorated with murals. These decorations can be dated back to at least two periods: around 1600 and certainly before 1630 when the church got a new gallery that covered parts of the murals.

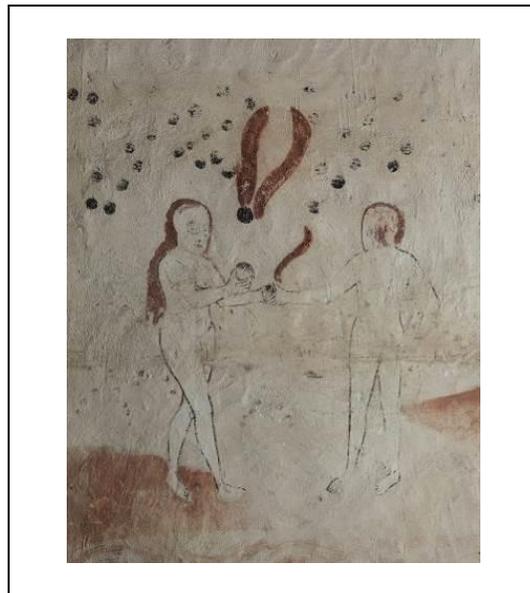
**Figure 4.** *The Fall* on the north wall in the nave. The Wisdom tree has disappeared due to fading of organic pigments. Fruits, now black in colour, originally had a red-orange hue due to the presence of red lead as a pigment. Photo: B. Lindstad, 2013.

Paintings appear today mainly in red, grey and black colours. Traces of green can also be observed, suggesting that originally the chromatic range was richer than that visible today. The paintings are applied on a thick lime layer using a *secco* technique, which means pigments mixed with a binding medium and applied on dried plaster. The analysis of pigments showed that iron oxides were used for different shades of red, and carbon black was employed for black. Red lead was also found, which has now turned into black compound (Figure 4).

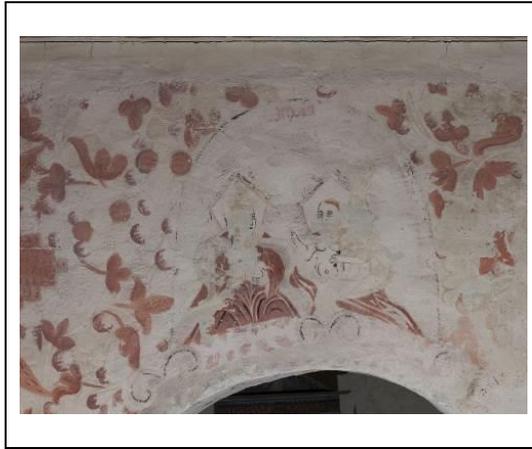
**Figure 7.** *The Trinity* above the chancel arch in the nave. The motif is hard to read due to major lacunas. Photo: B. Lindstad, 2013.

The figure group above the chancel arch in the nave has been interpreted by various scholars. But, due to degradation and some major lacunas, the scene is difficult to read and interpretations have often been contradictory and wrong [2, p. 67, 69; 3, p. 161; 4-8]. The scene shows two figures facing each other and an indistinct dove above them (Figure 7). The group is located under a painted arch and ‘Jehovah’ is written in the upper part. The dove is hard to see from distance, and some missing lines provide convincing explanation for the misinterpretations. The motif has been described as *The Trinity* [2, p. 67; 3, p. 161; 5], but also as “... two women with bare breasts” [7] and the latest interpretation, as Mary showing her breast to God in the intercessory prayer [4].

A deeper study confirms the hypothesis of *The Trinity*, with God the Father on the left holding a sceptre in his right hand and a globe in his left.

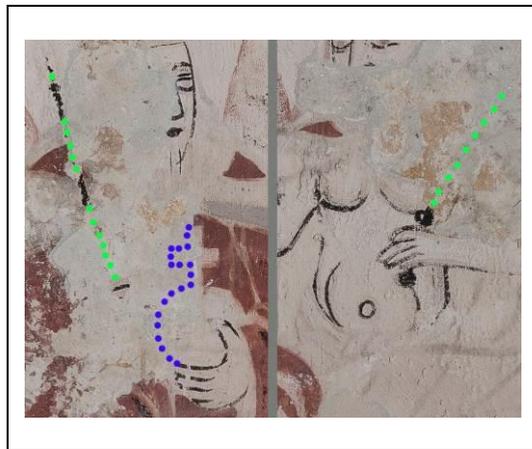
**Figure 8.** Detail of *The Trinity*. The figure on the left (as we look at it) holds a sceptre in his right hand and an orb in his left. The green and blue marks should help the observer to fill in missing parts of the design. Photo: B. Lindstad, 2013.

On the right-hand side of God is his son, Jesus. He holds a sceptre in his right hand and does the sign of benediction (blessing) with his right hand (Figure 8).

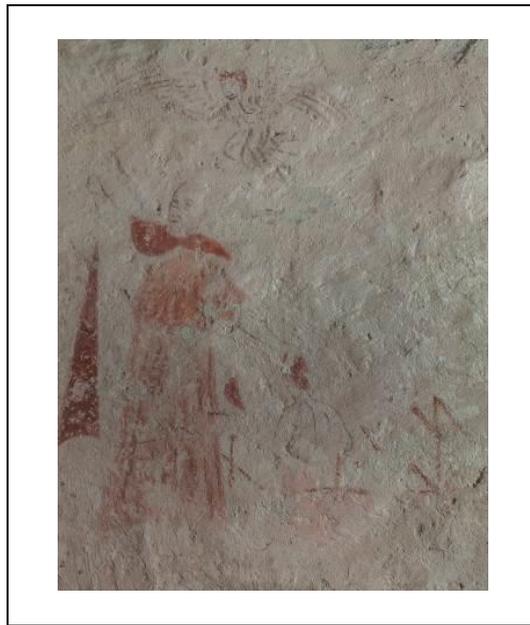
**Figure 9.** *The Sacrifice of Isaac* on the north wall in the chancel, photo: B. Lindstad, 2013.

Above the Father and the Son, the Holy Spirit is positioned in shape of a dove. The group is located under a painted arch and 'Jehovah' is written in the upper part. The murals on the north wall in the chancel represent biblical scenes from the Old and the New Testament. In the upper part of the north wall, *The Sacrifice of Isaac* (Figure 9) and *Resurrection* are painted. The lower parts of the

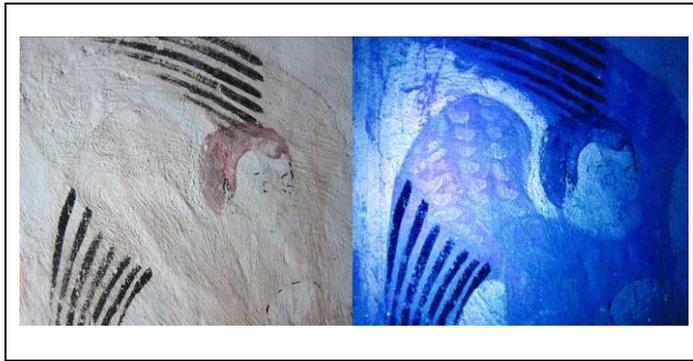
**Figure 11.** Detail from *The Annunciation* in normal light (left) and ultraviolet light (right). UV fluorescence made feathers in the angel's wing visible. Photo: S. Kaun, 2012.

Due to fading of pigments, some details have almost completely disappeared, such as the ox in the *Nativity* scene (Figure 10). The head is completely lost, and only the white horns are visible. UV radiation helps to make some lost details visible, such as the feathers on Gabriel's wings in the *Annunciation* scene (Figure 11). We do not know the original colours of these details, but it may be supposed that they were painted with organic pigments that have faded over time and are no longer visible. What we see under UV is associated with the organic binder fluorescence. These examples show us that the murals in Moster were once much more colourful and had more details than those we can see today.

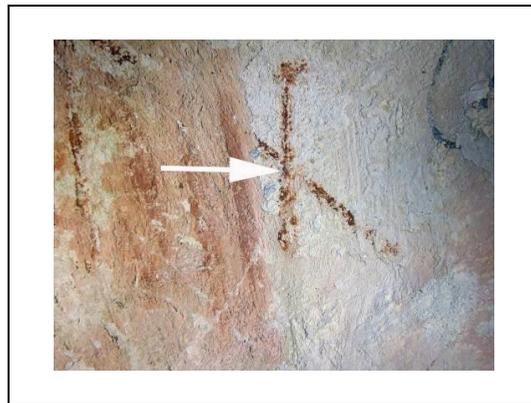
**Figure 12.** Detail from the chancel wall. The arrow shows runes, painted in red. The runes are painted on a layer underneath the post-Reformation murals, and they can be seen in lacunas. Photo: B. Lindstad, 2013.

It is obvious that these old decorations were covered when the new paintings in the 17<sup>th</sup> century were created. Rune inscriptions are also visible in several places in the church underneath the post-Reformation decor [O. Seter, *Moster gamle kirke. Kalkmalerier (Moster old church. Murals)*, unpublished report, Directorate for Cultural Heritage, Oslo, 1952, p. 2]. Traces of red paint depicting runes can be seen in missing parts of the post-Reformation paint layer (Figure 12).

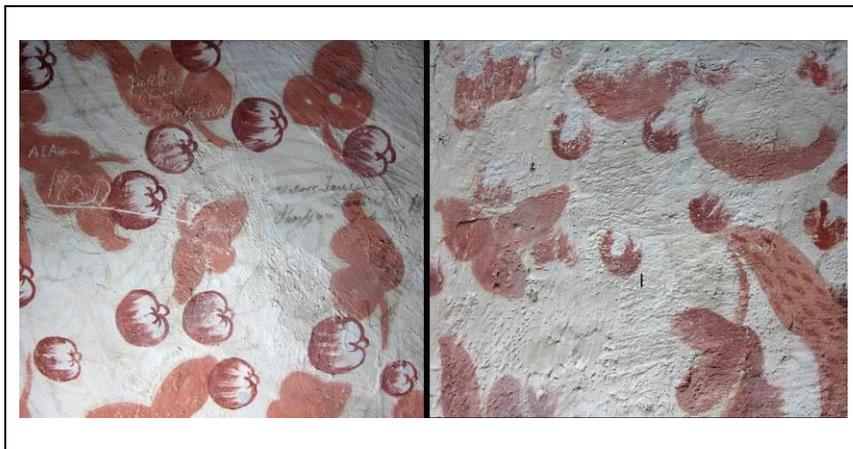
**Figure 13.** The foliage and fruit decor on the nave's north wall (left) compared to the apparently similar decor on the east wall (right). The latter appears to be of poorer quality and the fruits are less distinctly painted. Photo: S. Kaun, 2012.

New observations show that the foliage decorations in the nave were also painted in two stages, even though they look similar. The surface study and raking light make it obvious that two different hands executed the foliage decors

on the northern and eastern walls (Figure 13). Plaster stratigraphy showed that the eastern wall was decorated later. The yellowish red colours in the *Calvary* scene on the eastern wall indicate that this motive was also painted at another stage (Figure 14, left).

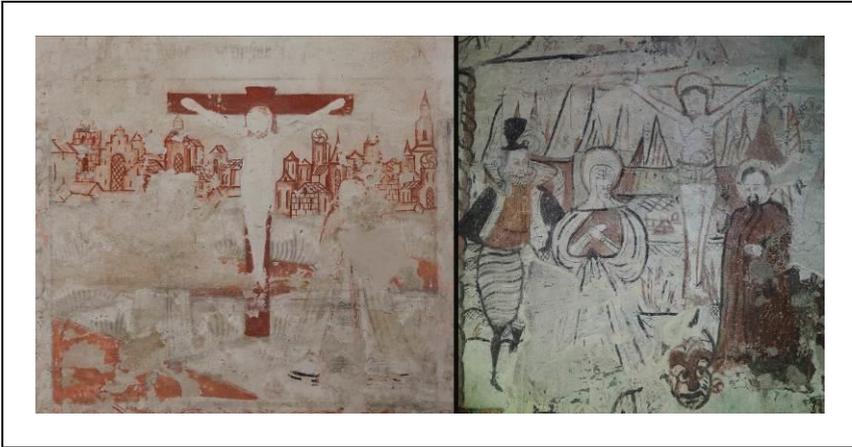
**Figure 14.** Crucifixion scenes are typical of Norwegian post-Reformation decor: Moster Old church (left), Dale church (dated around 1560, right). Photo on the left: B. Lindstad, 2013, photo on the right: S. Kaun, 2016.
