THE WOODEN DOOR IN THE EX-ABBEY OF SAINT SECONDO

IDENTIFICATION OF THE BOTANICAL SPECIES

In this contribution, the wooden door of the ex-Abbey of Saint Secondo in Amelia (province of Terni, Italy) has been investigated with the main objective to gather information of its state of conservation to supply information for the restoration process. After restoration, samples from replaced boards were also examined. The investigation was performed through direct observation and analysis of wood micro-samples in the laboratory for characterising the species.

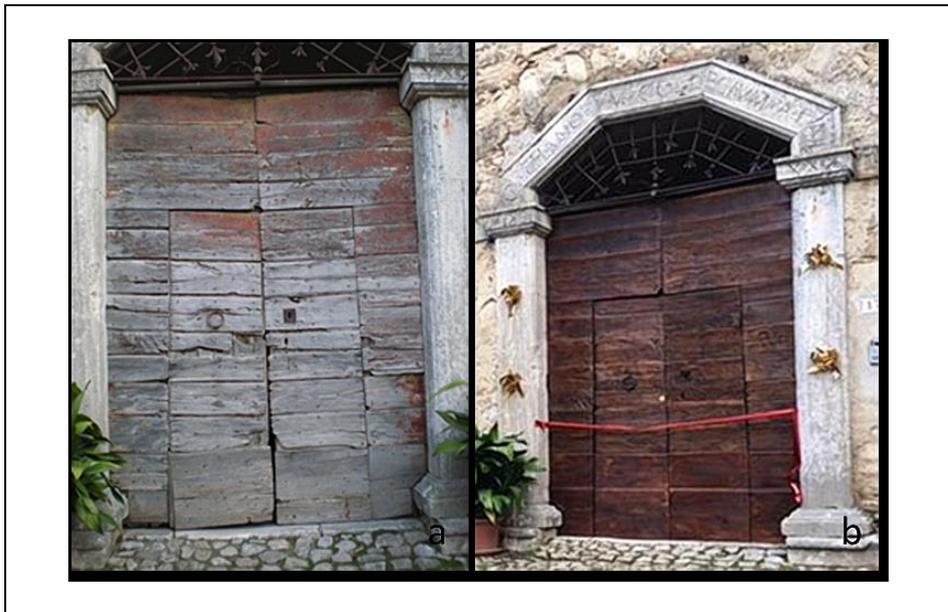
Figure 1. The door in the ex-Abbey of Saint Secondo: (a) before and (b) after the intervention. A smaller door is opened within the main one.

The restoration started with the removal of dust and debris accumulated on the whole surface by using detergents, water and delicate metal brushes. Subsequently, the removal of the double lining in the lower part was followed by the delicate stage of reconstruction of the deteriorated parts.

The poor conservation state of the inner side required intervention aimed at restoring the door functionality. The reconstruction of the lower part has been made by jointing the vertical boards of the original part with the new ones in elm wood (Figure 2a). The outer layer showed a very critical situation due to chemical and physical degradation processes but also to the lack of correct ordinary and planned maintenance. The deterioration of the surface was caused above all by light sun exposure without any wood protection. The original colour of wood was turned to a silver-grey one, due to the surface photo-degradation [7-10]. The external layer of horizontal boards has been restored, with the care to preserve the original materials and to maintain the aesthetic appearance. Subsequently, the two door wings were aligned and consolidated by applying, in the upper part, two iron bars secured by screws. Finally, where necessary, plugs were inserted made of elm wood, vinyl glue and wood powder. The puttying was carried out with Balsite, un-shrinking resin-based filler. It can be coloured with earths and oxides and easily sanded. The final stage was to restore colour and make uniform the new parts with the originals. This goal was reached by three applications of boiled linseed oil diluted with petroleum in the volume ratio 3:1.

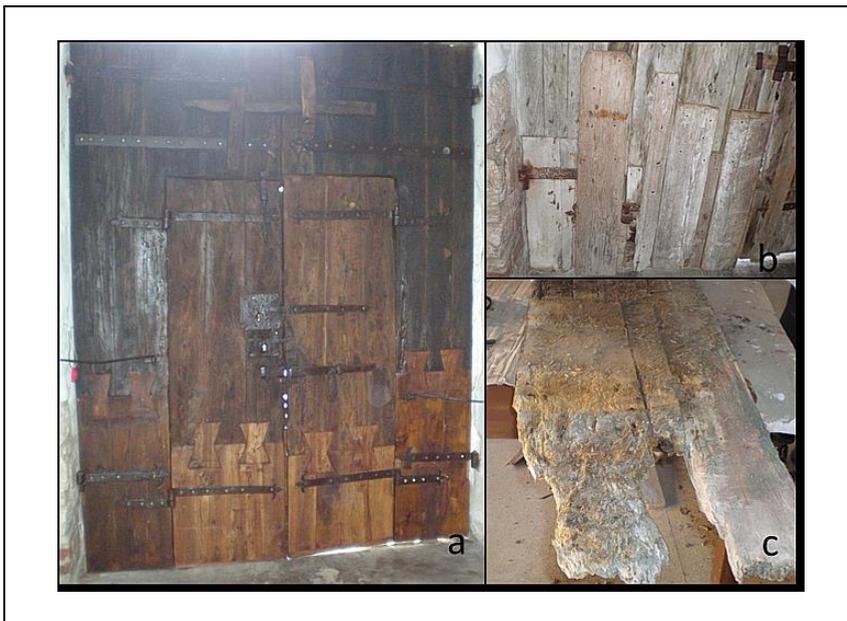
Figure 2. (a) Vertical board assembly in the inner side, after the intervention. (b) Detail of the conservation state before the intervention and (c) decayed boards in the lower zone, inner side, during restoration.

The evaluation of the conservation state, which preceded the restoration, highlighted the presence of gaps in the outer part in correspondence of the joints.

The lower side appeared extremely deteriorated (Figure 2b and 2c), the left door was remarkably warped as well as some of the boards of the outer layer and the surface protection was missing. In the lower part new boards badly replaced the original ones to maintain the door functionality.

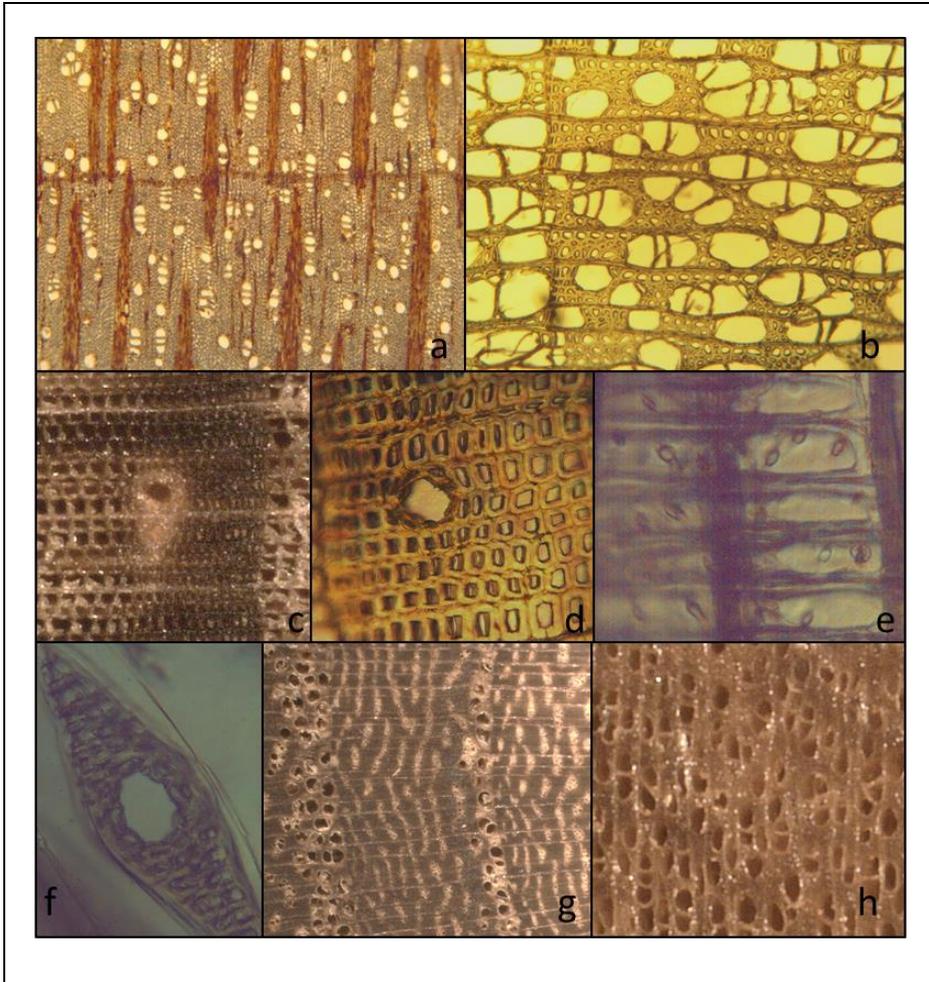
The sample was cut to obtain thin section to perform the microscopic observation of the anatomical feature. In transversal section (Figure 3a), presence of distinct growth rings; diffuse porous wood; scattered vessels, solitary or in radial rows of 2-3 elements, with constant diameter in the transition from early wood to late wood; apotracheal parenchyma widespread were observed. In radial section, simple perforation plates, presence of spiral thickenings on vessels walls, homogenous rays were detected. In tangential section, multiseriate rays up to 6 rows of parenchymatic cells were observed.

Macroscopic and microscopic analyses of the anatomical structure of the sample showed that the examined wood belongs to the genus *Acer*. The number of rows of the ray cells up to 6 (a significant diagnostic feature for the species identification [6, p. 70]) makes evidence to the hypothesis that the wood

Figure 3. Anatomical features of the examined wood samples: (a) Maple: transversal section (microscopy magnification 40x); diffuse porous wood with a distinct growth ring and pluriseriate rays up to 6 rows of parenchymatic cells. (b) Poplar: transversal section (10x); diffuse porous wood with a distinct growth ring and uniseriate rays. (c, d) Spruce: softwood with resin canal, thin-walled epithelial cells (stereoscope imagine 32x), optic microscope imagine 25x). (e) Spruce: radial section (40x); pits in cross-field small, 2-3 per cross-field. (f) Spruce: resin canal in tangential section (40x). (g) Elm: transversal section (12,5x); porous rings in early wood, latewood pores in wavy (ulmiform) tangential bands. (h) Poplar: transversal section (11x); diffuse porous with uniseriate rays.

The removed boards were found decayed and insect attacked. Two boards belonged to species of the genus *Ulmus* (Elm) (Figure 3g), two to the *Picea abies* (L.) Karst. species (Spruce) (Figure 3c, d, e, f). A sample of the outside layer, studied in the second diagnostic campaign, belongs to genus *Populus* (Figure 3b) (Poplar).
