CONSERVATION PROBLEMS IN THE VATICAN NECROPOLIS

Daniela Gallo^{1*}, Pietro Zander² and Claudia Pelosi³

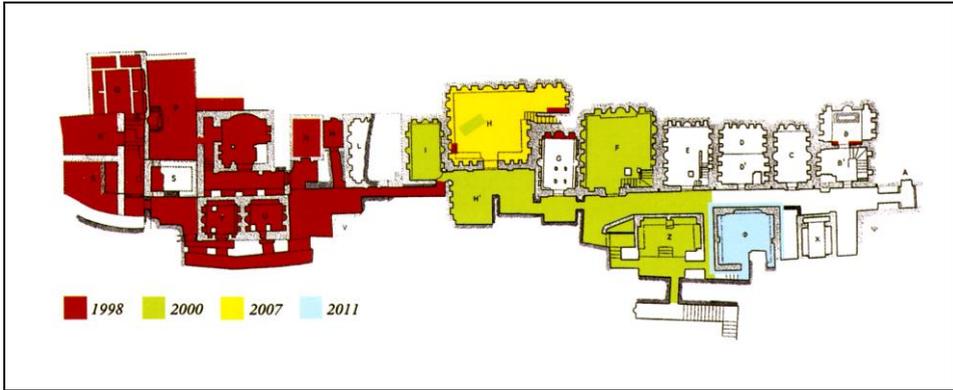
Figure 2. Plan of the Vatican Necropolis showing in different colours the restoration dates of mausoleums (from [3, p. 110], ©Fabbrica di San Pietro).

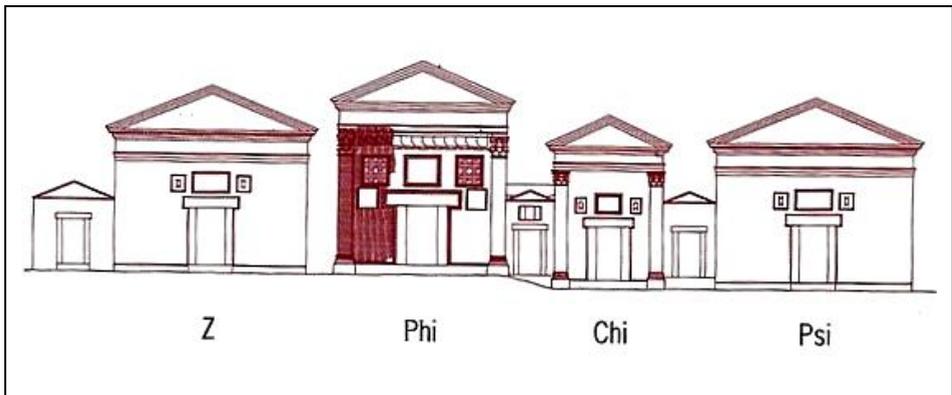
Figure 3. Reconstruction of Mausoleums Z-Psi ([7], ©Fabbrica di San Pietro).

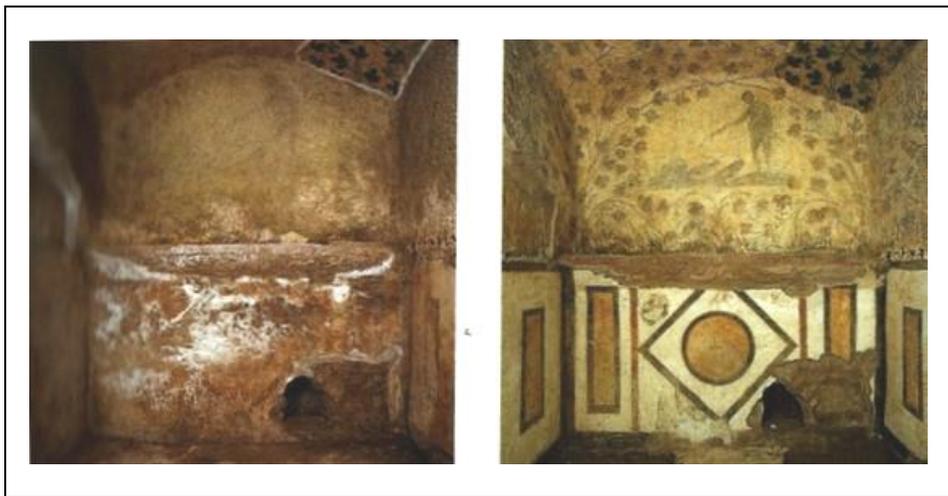
Figure 4. Vatican Necropolis, Mausoleum M, interior north wall with the Christian figure of the fisherman before and after restoration (from [3, p. 113], ©Fabbrica di San Pietro). Soluble salts are clearly visible before restoration.

caused evident and progressive deterioration patterns. The degradation phenomena were visible on the surfaces through the formations of salt (chlorides, sulphates and nitrates, Figures 4 and 5), algae and microorganisms which over time developed so covering walls and pictorial decorations [8-11]. Increasing number of visitors over time (Figure 6) also contributed to the gradual deterioration, as they brought in spores and bacteria, causing harmful micro-climactic variations.

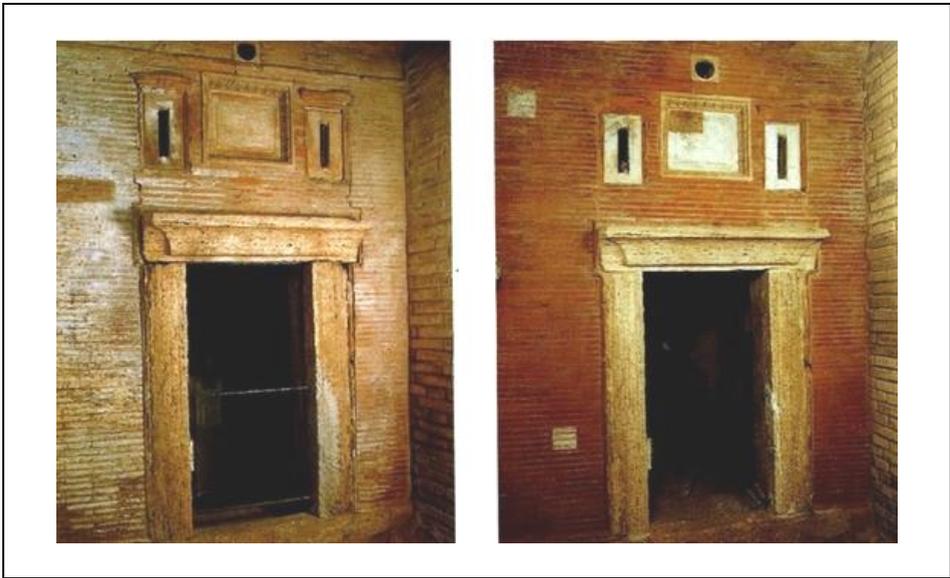
Figure 5. Vatican Necropolis, Mausoleum N, exterior south wall before and during the cleaning operation (from [3, p. 116], ©Fabbrica di San Pietro).

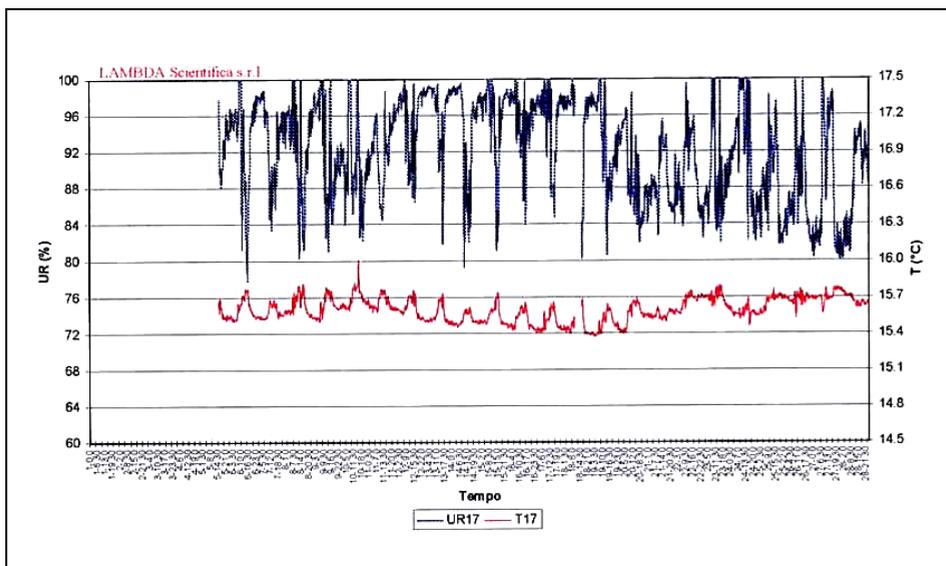
Figure 7. Microclimatic performance before installation of the crystal doors (from [9, p. 305], ©Fabbrica di San Pietro).

A comparison of air temperature and RH% values with the thermal measurements on the walls, made possible to evaluate the presence/absence of periods with unfavourable environment parameters that could negatively affect the surfaces. This was obtained by assessing the occurrence frequency of risky thermohygrometric conditions. The data gathered in the period 1992-1994 showed that the entire structure of the Necropolis was not immediately affected by the daily thermohygrometric variations, following the external meteorological climate (as is typical of subterranean environments), being however affected by the seasonal variations (Figure 7). Great instability, especially of RH% was detected, as visible in Figure 7.
