# THE RELEVANCE OF MONITORING THE MICROCLIMATE IN MUSEUMS THE CASE OF COLLE DEL DUOMO IN VITERBO

Microclimate monitoring is a fundamental step in preventive conservation and must be taken into account in the planning of museum expositions and in other confined environments, as stated by international standards produced by the technical body CEN/TC 346. This contribution synthesizes the results of extensive monitoring campaigns in the Museum of Colle del Duomo, a diocesan museum located in the important complex of the Papal Palace of Viterbo (Central Italy). The museum contains different kinds of religious objects such as reliquary busts in wood, papier-mâché and metals, sacred clothes, panel paintings, gypsum 'modelli', and also archaeological artefacts. This wide variety of materials makes particularly difficult to maintain environmental parameters, such as light, relative humidity and temperature, within the ranges of values recommended by the Italian and European standards for Museum conservation. However, the monitoring campaigns allowed to know the most critical situations and to intervene with solutions aimed at mitigating the effects of microclimate on the artefact material

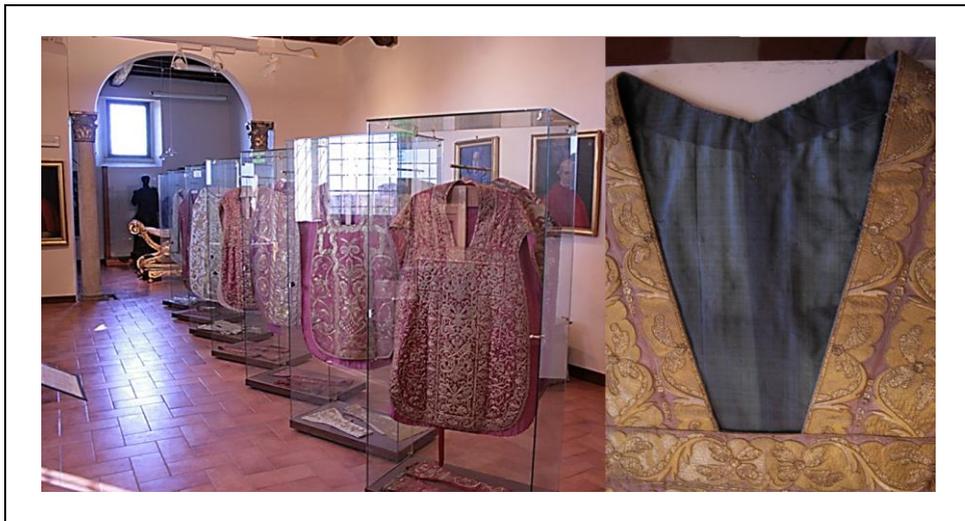
In the case of the Sacred Vestments room (Figure 1), in addition to the RH% and T (°C) values, the illuminance and radiance values were also recorded with both the closed and the open windows. The values obtained on a sunny day

in June (Table 1) highlight that, especially with the windows open, the maximum permitted by the UNI for illuminance (50 lux) is far exceeded.

**Figure 1.** A view of the Sacred Vestments room and a detail of discoloration due to light. The part covered by the coat hanger clearly maintained its original blue colour.

For this reason it was suggested to leave the windows closed, especially during the hours of maximum sunshine, and to provide the windows with simple screening systems. For completeness of information, it would obviously be necessary to carry out a monitoring all year round in order to calculate the annual dose of light and ultraviolet radiation that the artefacts receive and that is responsible for the strong discoloration observed in the hangings during the disassembly and re-fitting operations performed by the Ancient Textile Laboratory of Viterbo. The measures reported are therefore only indicative but still useful for identifying the general problem.

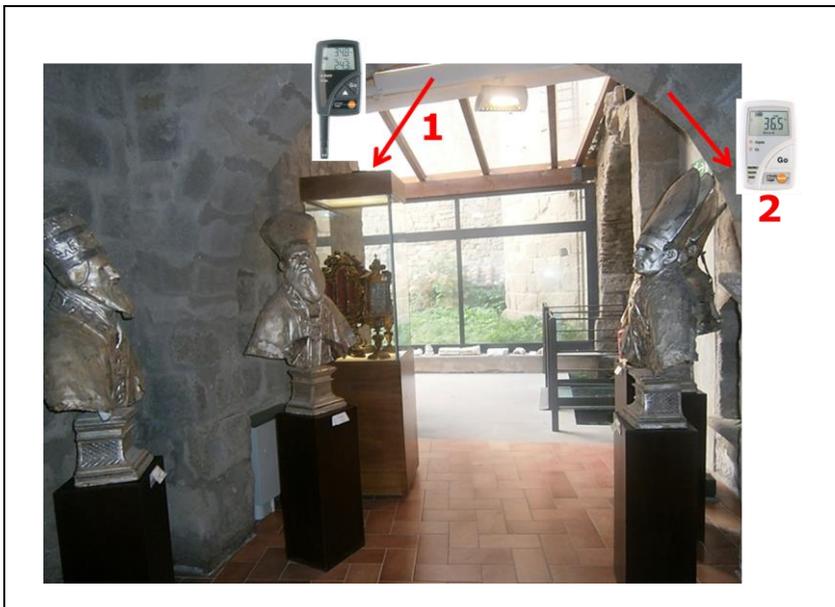
The most worrying datum concerns the oscillation of thermo-hygrometric parameters. Particularly the RH% on a daily basis also presents daily excursions of over 20% in the spring and autumn months, which partially is caused by the shape of the room (Figure 5). In fact, this is a sort of corridor exposed to air currents and to effect of door opening/closing.

Figure 5. A view of the reliquary busts room with the two data logger positions.

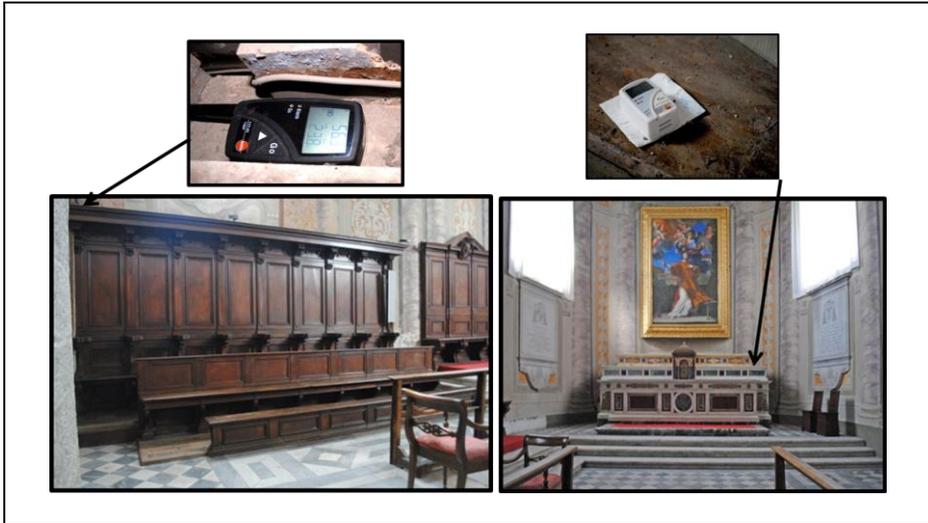
The choir area is a confined space behind the current apse of the Cathedral of Saint Lawrence in the Papal Palace complex (Figure 6). It is the baroque remain of the cathedral that was closed to reconstruct the original medieval asset of the apse after the destruction in the Second World War. At present, the choir area is under the management of Colle del Duomo Museum.

**Figure 6.** Two views of the choir area with the two data logger positions. The beautiful wooden choir and the painting attributed to Romanelli are visible in the images.
