# NON DESTRUCTIVE EVALUATION OF LANTERN TOWER CHURCH OF DRAGOMIRNA

Ileana Kisilewicz\*

## Abstract

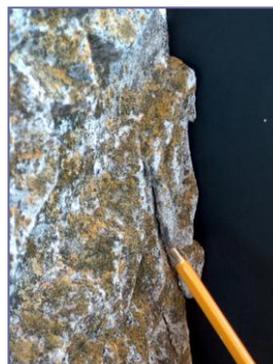
**Figure 4.** Detachment on contour scaling and deposits of biological colonization

The limestone was not suffering directly from physical weathering. Nevertheless, the stones showed alterations caused by an important biological colonization. The carved stone decorations were covered frequently by ‘biomats’. These are association of microorganisms, which are covering the stone surfaces like a skin. They could be found in different intensities on the

Especially, an alternation of different species could be observed on the surfaces with intense biological colonization. The biomats appeared not as a homogeneous layer, but as centres of growth or colonies, which were expanded.

Properly the growth of microorganisms by the intake and release of water could caused an increase or decrease of cells, thus it results a mechanical stress causing local disintegration or dissolution of mineral material on the limestone surface. In this way, the whole remains were formed by the former biological mineralization.
