**NON-DESTRUCTIVE TESTING FOR THE
ASSESSMENT OF STONE DECAY IN RELIGIOUS
HERITAGE
CHURCHES OF SAN ROQUE (SEVILLE) AND
NUESTRA SEÑORA DE LA ANTIGUA
(TORREALHAQUIME, CADIZ)**

Rosario Villegas Sanchez* and Fátima Arroyo Torralvo

*University of Sevilla, School of Engineering, Camino de los Descubrimientos, E-41092 Sevilla,
Spain*

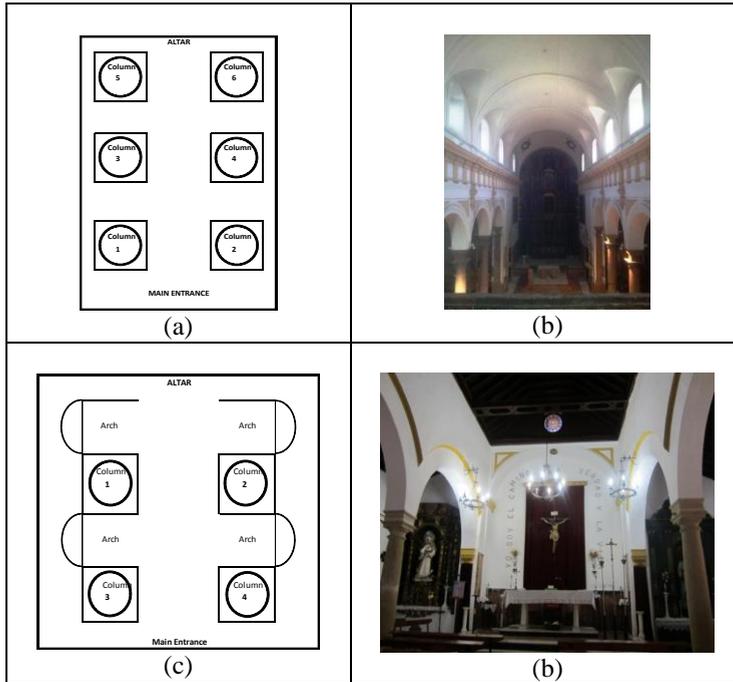
On both cases, the presence of fissures and cracks on some of the columns made the conservators to decide exploring the rest in order to detect non visible (internal) deterioration of the stone pieces that form the columns. The schemes of the plans of both churches appear in Figure 1.

Figure 1. Schematic plan and general view of altar and columns of: (a, b) San Roque church [parroquiasanroquesevilla.es]; (c, d) Torre Alhaquime church.
