TECHNICAL RESCUE WORKS ON THE CONSTRUCTION OF THE SAINT ANNE'S CHURCH IN WARSAW AS AN OPPORTUNITY TO STUDY THE TECHNIQUE, TECHNOLOGY AND ICONOGRAPHY OF THE XVIII CENTURY MURAL PAINTINGS

Katarzyna Górecka*

Abstract

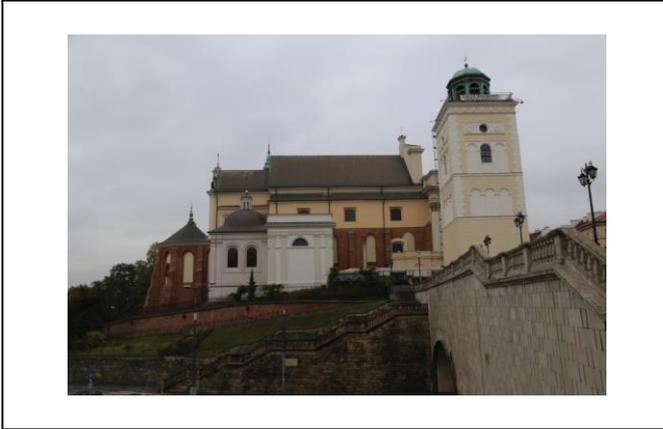
Figure 1. Saint Anne's church, general view of the north wall.

Due to its location the church building has been always exposed to structural problems caused by the subsiding of the Vistula escarpment (Figure 1). In the 50's during the construction of the WZ (East-West) road running along a tunnel close to the church and over the bridge to the other side of the Vistula, the slope stability has been disturbed. The foundations of the church and vault structure began to break due to the subsiding of the north-eastern part of the chancel. Immediate intervention prevented the temple from collapsing. The ground around the building was reinforced with columns and the foundation was encircled by a concrete wreath. The state of the building structure is constantly monitored. Recently new cracks on the ceiling and walls have been noticed. The slope movements have been diagnosed by inclinometers placed at 20m below the ground level.

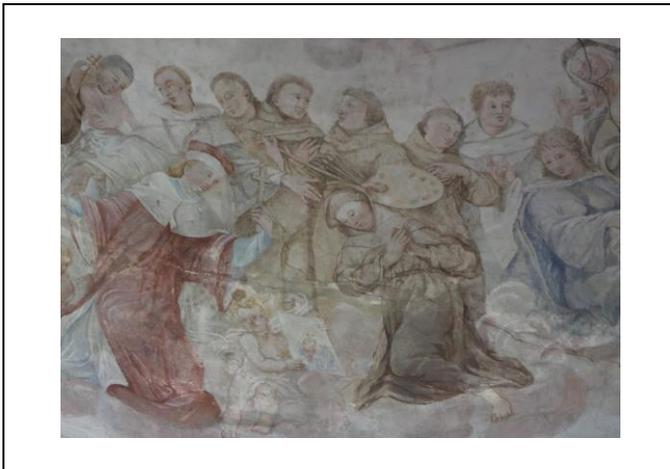
Figure 2. Valenty Žebrowski's self-portrait identified in one of the scenes.

Between 1743 and 1750 one of the monks, Valenty Żebrowski, accomplished a mural painting decoration in the church interior based on the extensive iconographic and religious program. The artist was born in Lubawa in the early XVIIIth century. He joined the monastery and became a painter of many monastic churches in Poland. He died in 1765. His self - portrait was recognized in one of the scenes painted in the chapel of the Saint Anne's church (Figure 2).
