MEGALITHIC BURIAL MONUMENTS IN THE BASQUE COUNTRY

A PROPOSAL OF ANALYSIS, DIAGNOSIS AND INTERVENTION

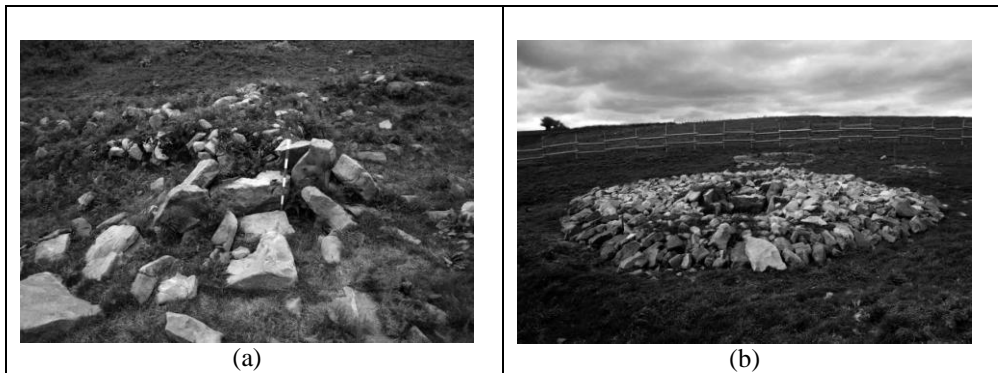
Figure 1. The preservation state of the Dolmen La Cabaña IV and its immediate natural environment: (a) before and (b) after the analogical reconstruction.

Specifically, in La Cabaña IV, Cotobasero II, Katillotxu II and Mendigana-Lerreder dolmens, analogical reconstructions have been accomplished based on archaeological reports. They showed important losses in the burial mound, displacement of the chamber's flagstones and incoherent image. The implementation of the categorised anastylosis system has returned a recognizable image and well balanced conservation state.

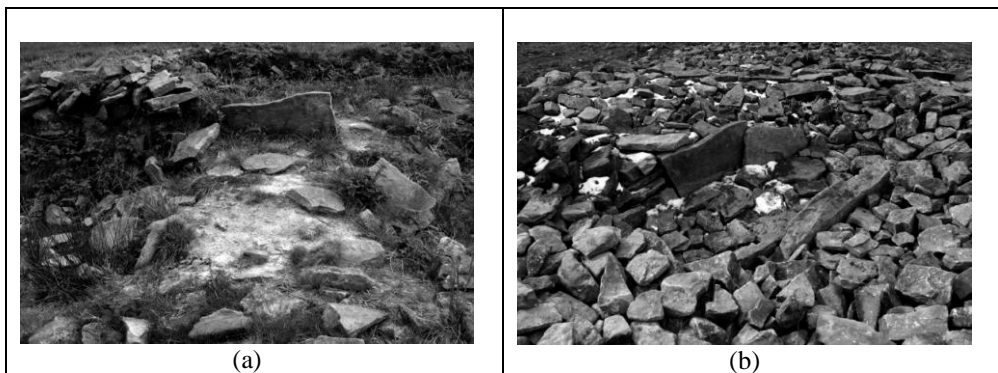
Figure 2. The preservation state of the Dolmen Cotobasero II and its immediate natural environment: (a) before and (b) after the analogical reconstruction.
